Mill Canyon Mine (Wooley Valley Unit #4)

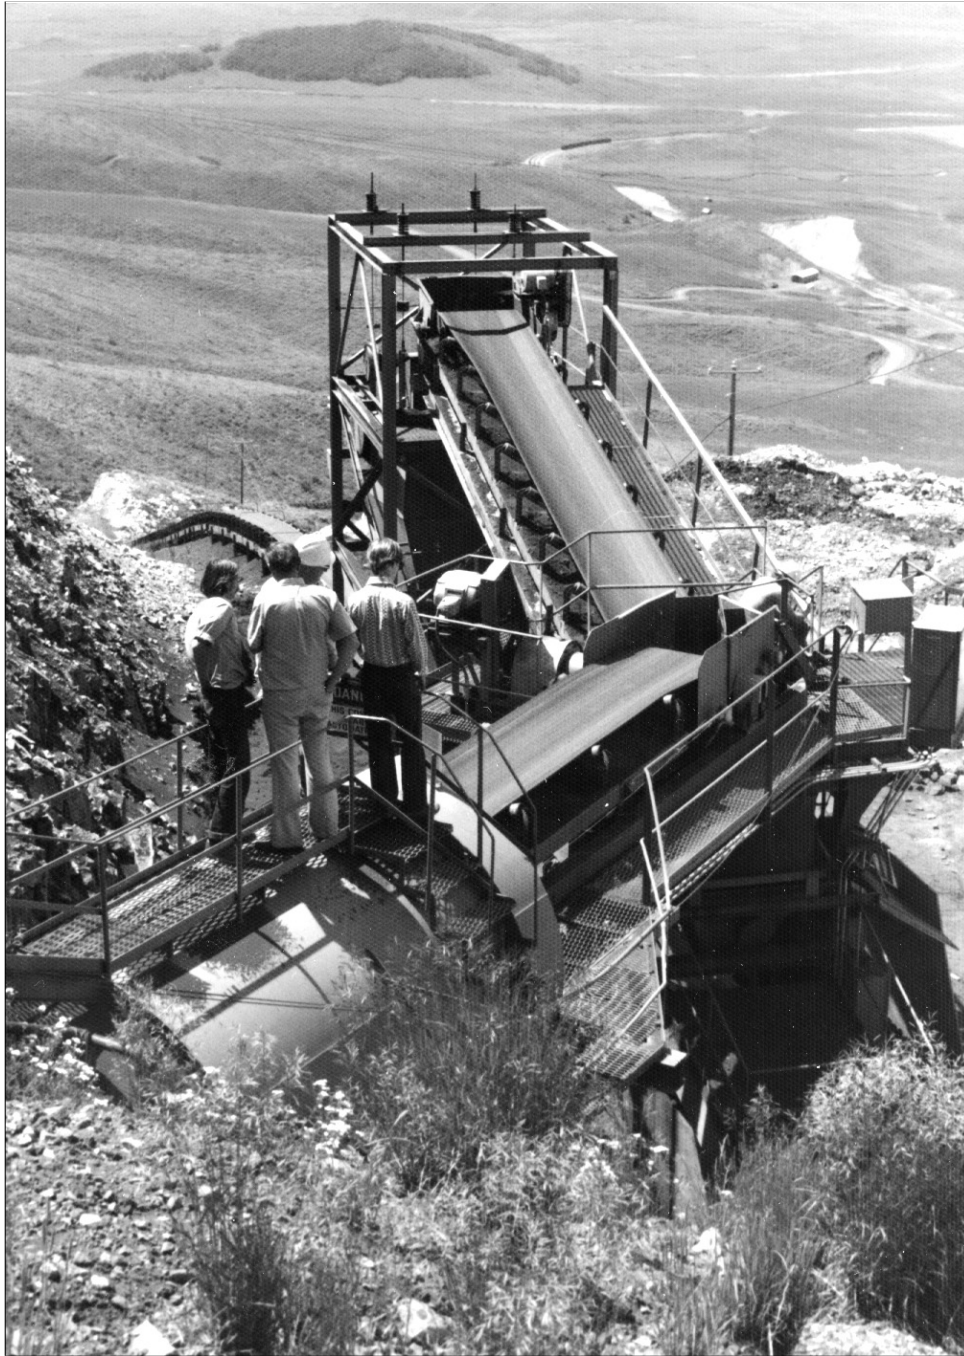
Figure 145. Ore conveyor belt, Mill Canyon Mine, July 30, 1975. BLM file photo.

Along with the advent of mining in 1969, the year also saw the construction of a conveyor belt from the mine area to the railhead (Figure 145). The belt was 30 inches wide and aligned in two segments down the hillside for a total distance of about 4,200 feet, an elevation drop of about 700 feet. Ore was fed from the stockpile area at the mine by a short 36-inch wide belt into a hopper over the tail piece of the long belt (see Figure 145). A surge bin was located at the lower end of the long belt from which the railroad cars were loaded from another 48-inch wide elevated belt. The whole conveyor system was rated at about 600 tons per hour. Scrapers brought the ore to the stockpile and bulldozers were used to load material onto the conveyor belt feeder assembly.

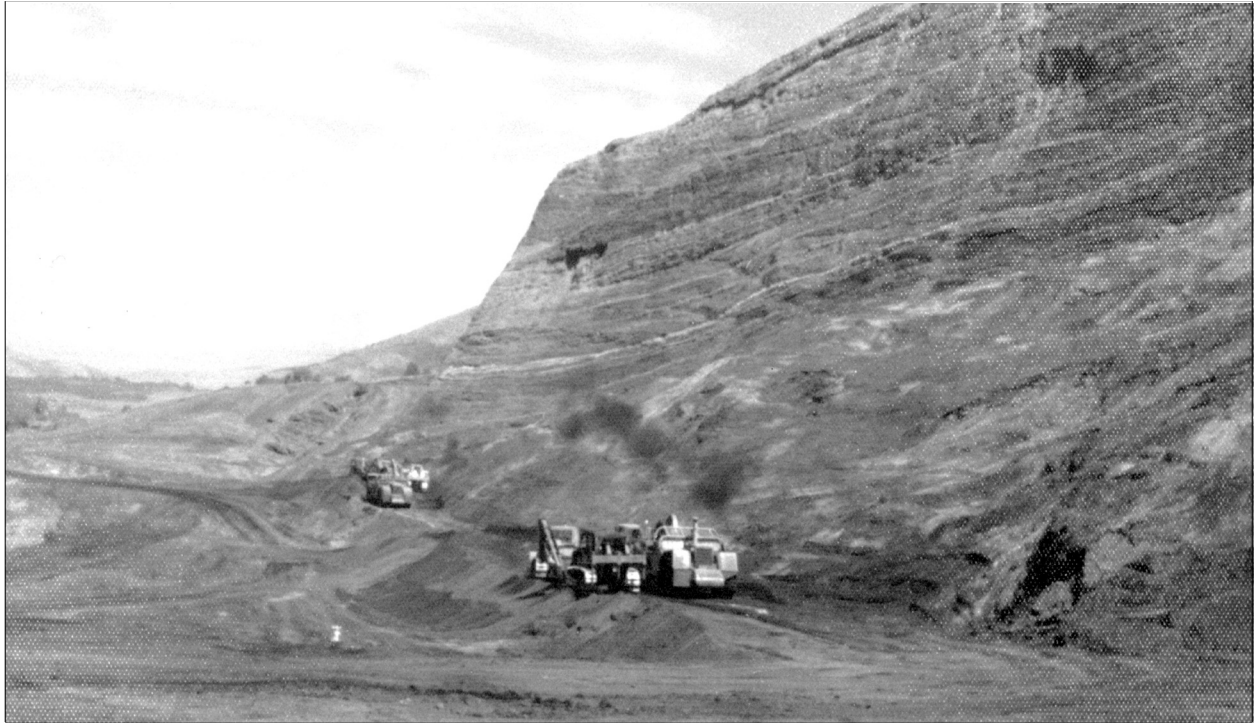
Figure 149. Mill Canyon Mine reclamation, view north, July 30, 1975. BLM file photo.

By September, 1974, all of the minable ore had been removed from the mine. Reclamation of the pit areas and the dumps was in full swing (Figure 149). Some ore remained on the east end of the lease near the Mill Canyon drainage, but it may not be economically recoverable.
